Date: 5/30/13

Engine Information: R-1340-AN-1  
Engine Serial Number 13580  
Covington Work Order 11883  
Date of Disassembly 5/6/13

This report is in response to Par Erixon request after conferring with Covington Aircraft Engines since early 2011 with regards to concerns about the engines recent overhaul. Visible signs of corrosion, oil consumption, and leaks were areas of initial concern. The engine was shipped to Covington and disassembled in the presence of an external expert witness.

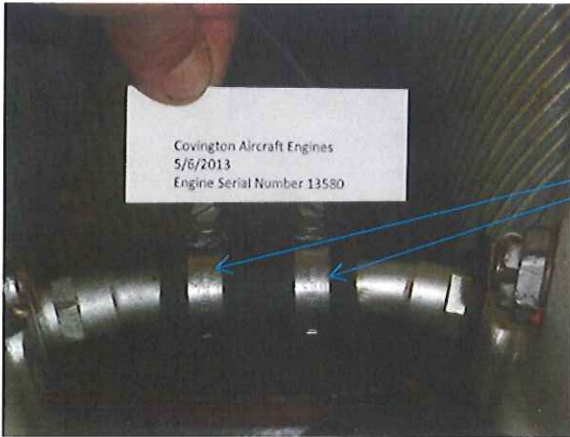
Incorrect Hardware (clamps) was used in all cylinder-to-cylinder drain lines. The clamps used appear to be general purpose hardware. The correct Part Number is 395296 as listed IPC Manual.

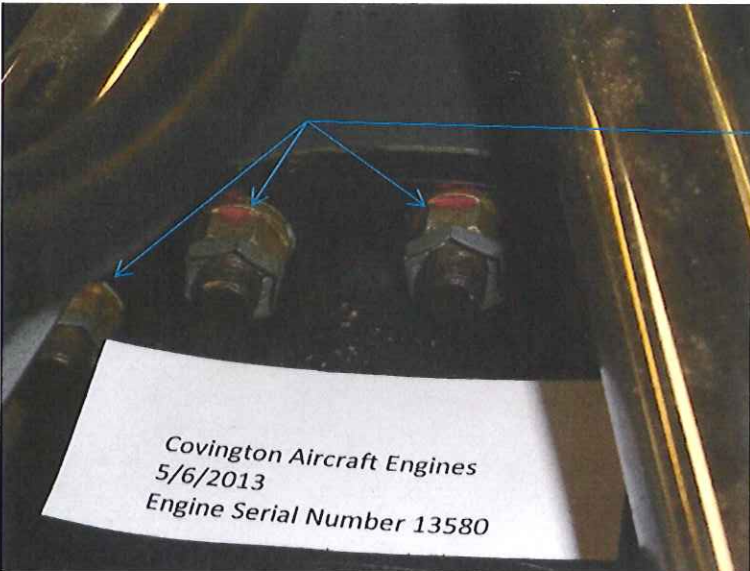
100% Incorrect cylinder base nuts were installed. The correct part number is 110514 as listed IPC Manual.

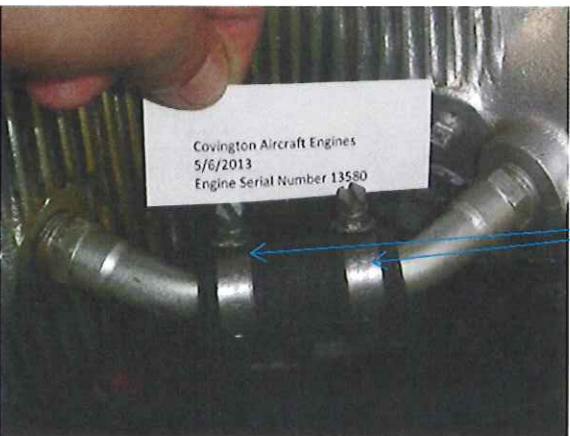
Incorrect hardware clamps used. The correct part number is 395297

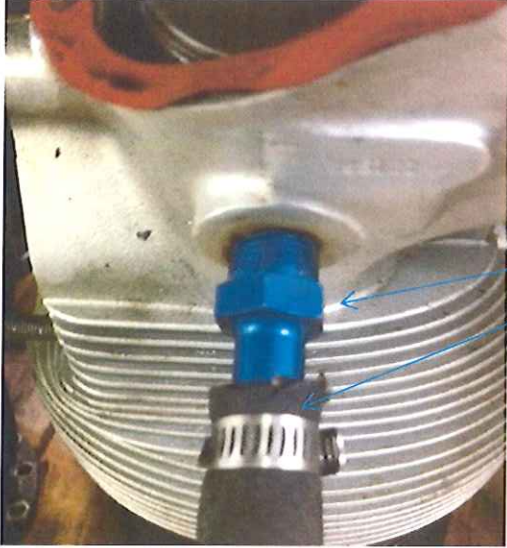
Note : Incorrect engine hardware used. The clamp and drain nipple used are general hardware. The correct part number for drain nipple is P/N 14669 & the clamp part number is P/N 395296.

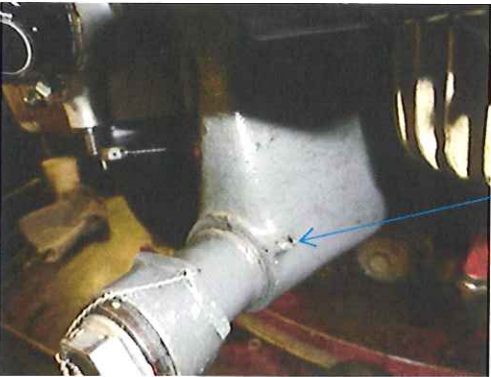
Note the oil sump "neck" is not safety wired & the safety wire lug is pulled through. No safety wire was evident at disassembly.

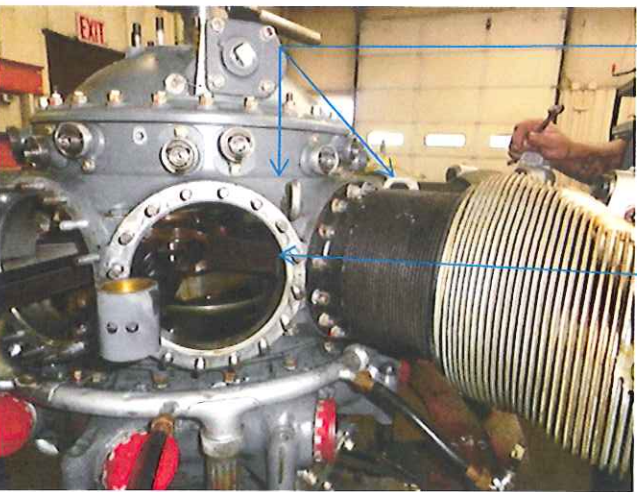
Note that the engine lifting eyes are located on the top of the case which is the configuration for helicopter installations. Fixed wing applications require the lifting eyes located behind the cylinders.

The master rod (P/N 39737) is located in the No. 1 cylinder location. This is direct contrast to the overhaul manual which states "Be certain that masterrod fits in the opening for the No. 5 cylinder"

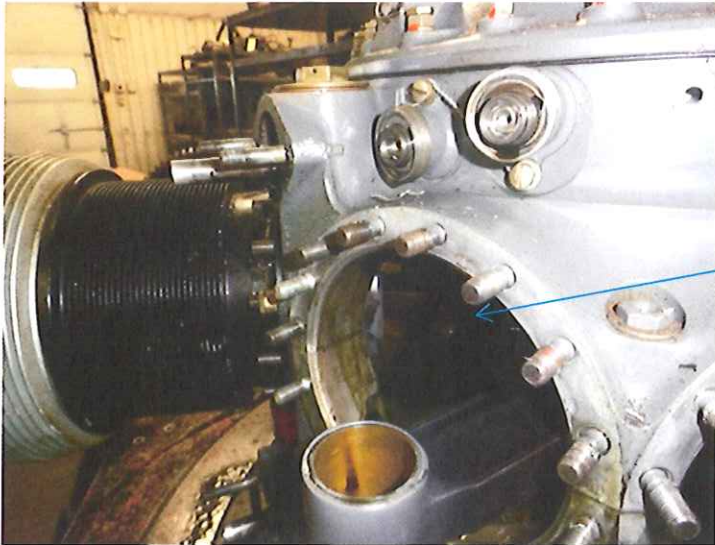
As shown, Link Rod (P/N 3469) located in the No. 5 cylinder position.

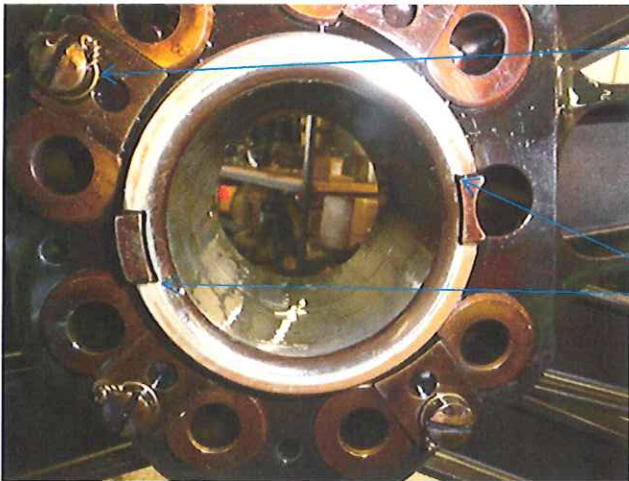
Lockwire securing lock bars require no less than .051 per the overhaul manual. The lockwire used on this assembly is .041.

It is widely accepted to accomplish SB1546 which allows for the corners of the master rod bearing lip to be dressed. This aids in reducing crack causing stress points in the bearing. Covington Aircraft observes this S.B. And will not release a repair or overhaul that has not had this S.B. accomplished.

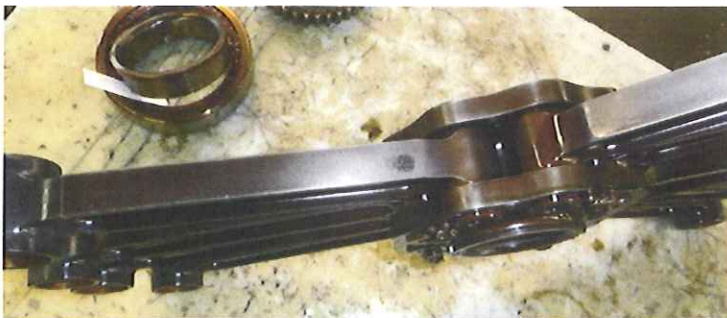
Corrosion found on the rod as pictured. It appears there were attempts to clean the corrosion, however by Covington tolerance & our understanding of the functionality of this part, this part is rejected and not repairable. See inspection letter attached.

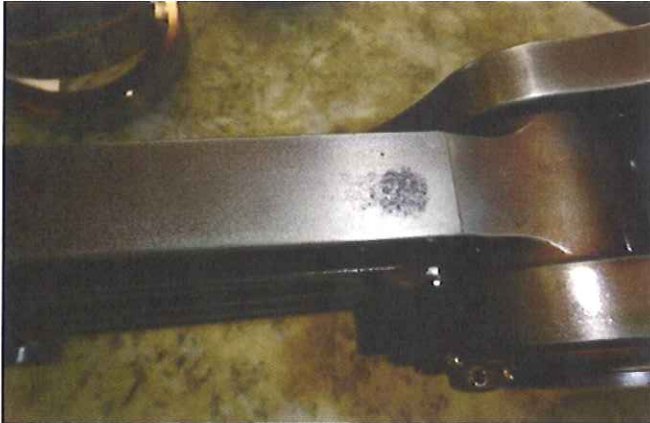
Closer view of the corrosion in question.

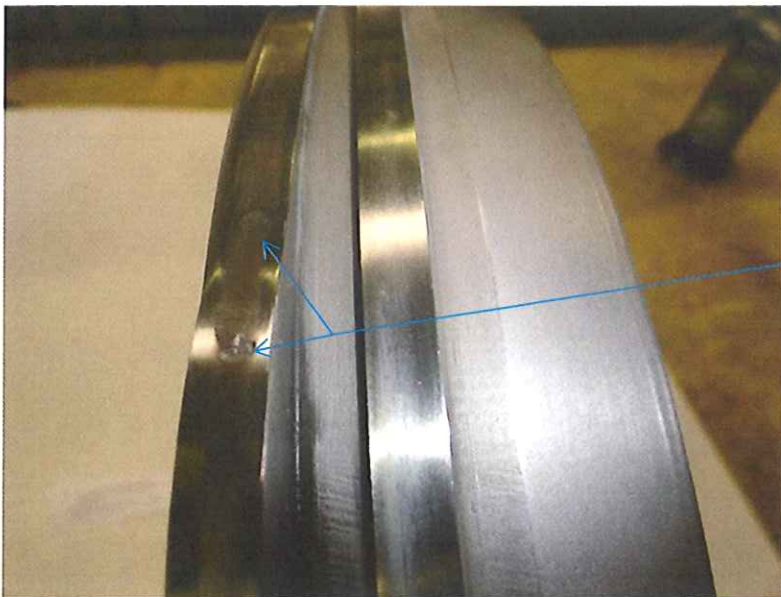
As shown deep pitting and tracking are evident on the Cam (Serial Number 118418). The cam is operationally failing and unable to be repaired and put back into service.

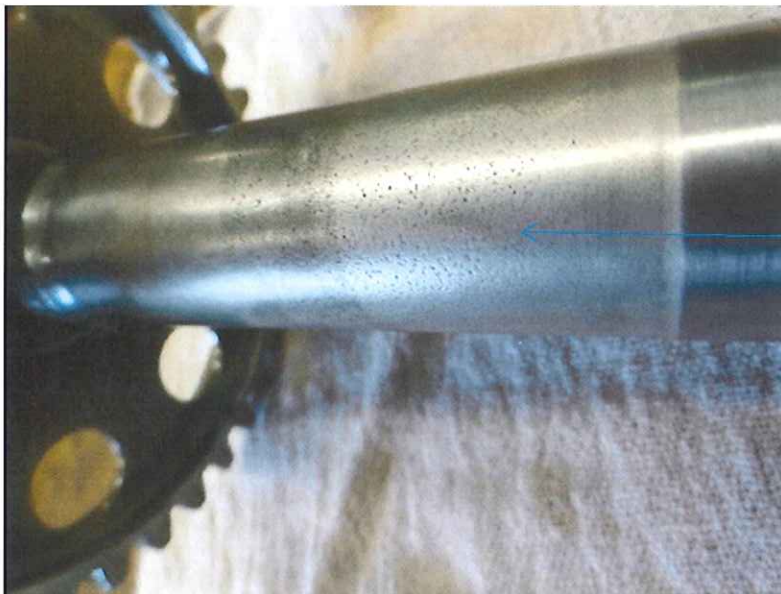
Starter Gear (P/N 3278) as removed. No rust or corrosion was present however deep surface pitting is present on the gears shaft.

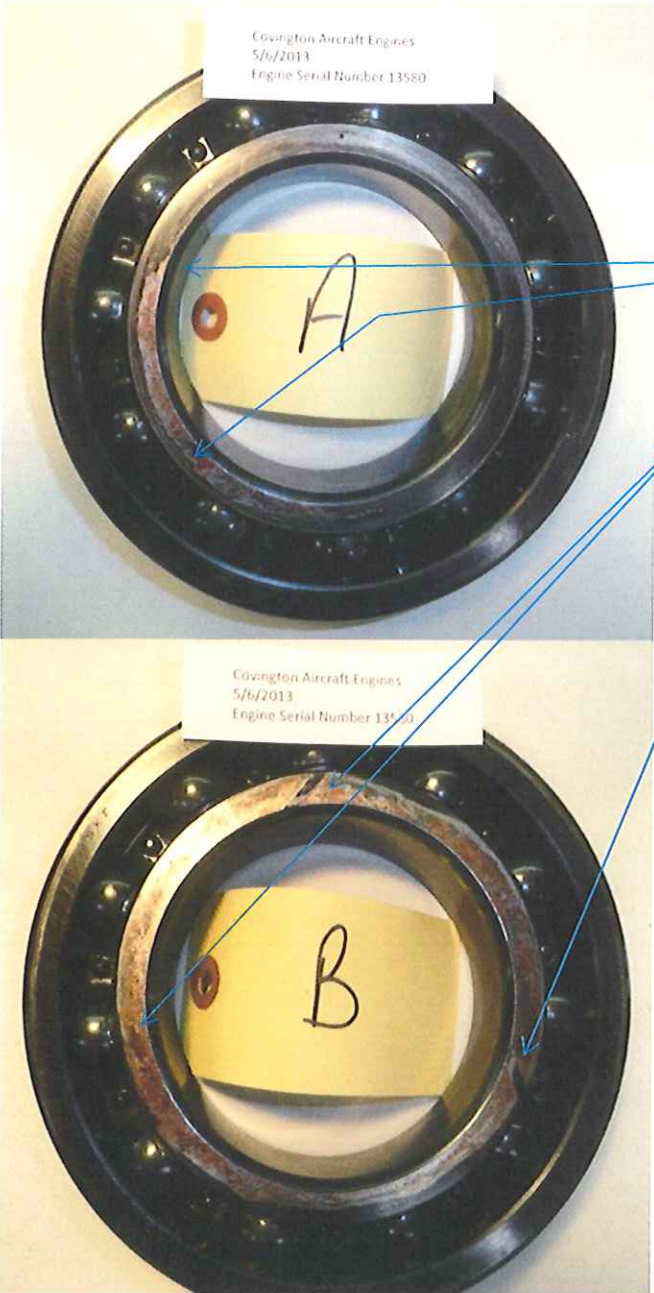
Trust bearing (P/N 326197) show witness marks from the engines slinger ring (P/N 303732). This does not reject this bearing however it would appear that this bearing has been installed more than one time.

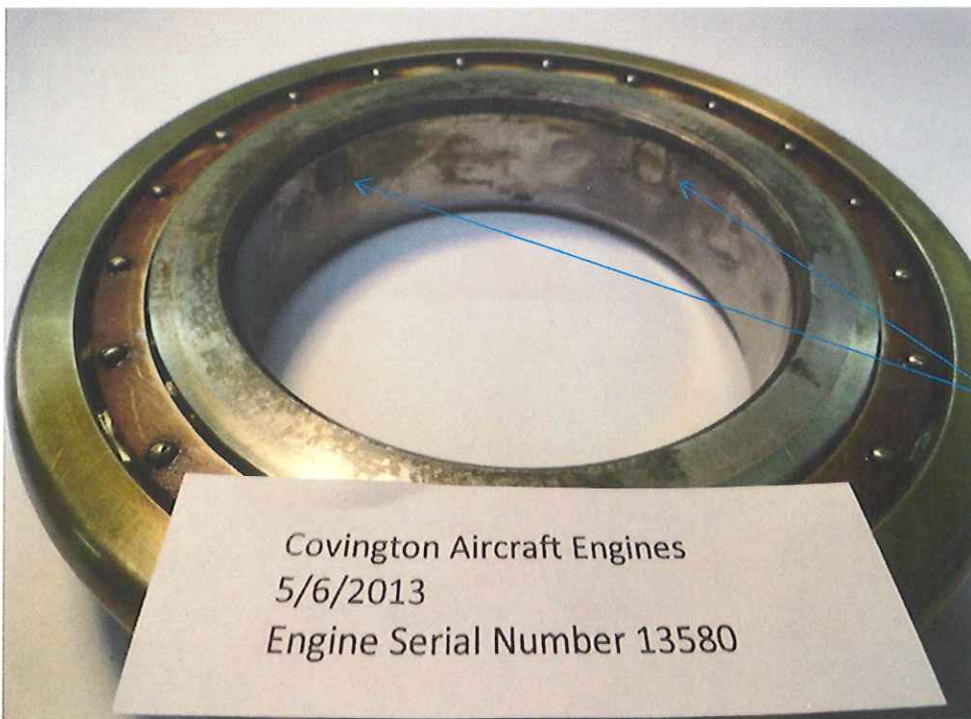
Front Main Bearing (P/N 288941) as removed. This bearing is in serviceable condition. Note the witness marks on the inner race of the bearing. This is caused by an access port on the crankshaft. There is only one port on the shaft that lines up with this bearing race. This bearing would appear to have been installed more than one time.

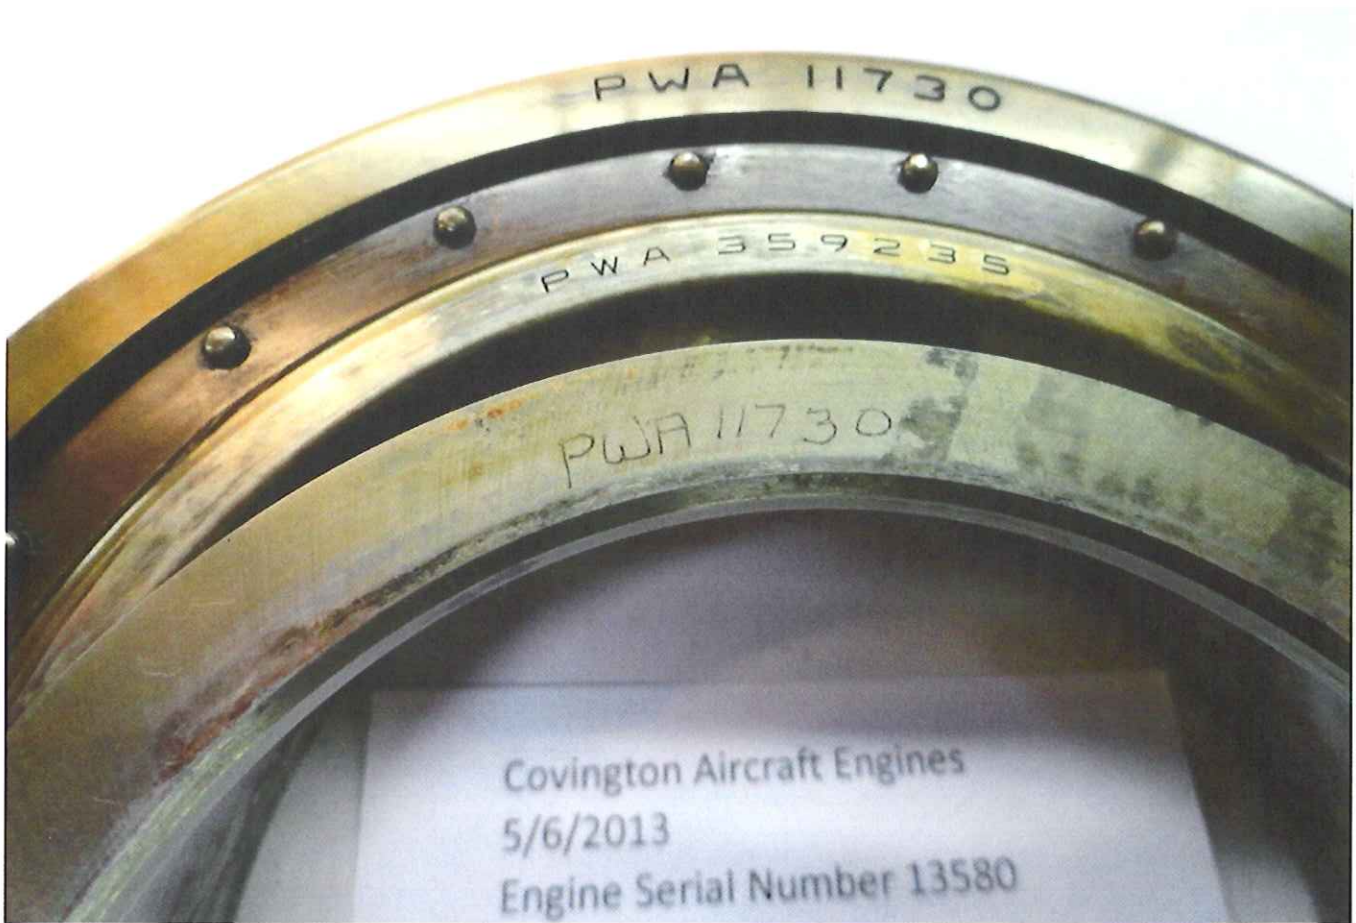
The rear main bearing as photographed (P/N288941) is in serviceable condition. Please note that the part numbers from the inner race does not match the part number of the outer race and retaining ring. Although this is acceptable, it would indicate that the bearing was not new when installed.

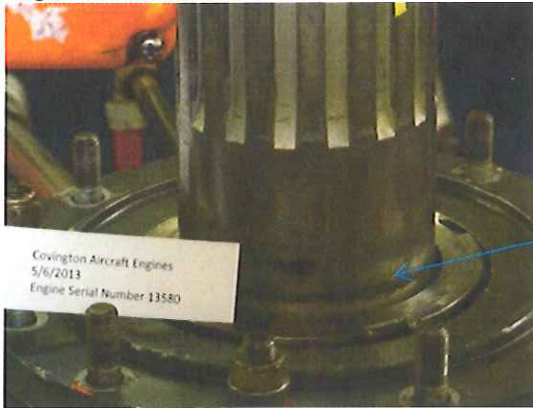
Corrosion and Pitting are evident on the crankshaft forward of the thrust nut (behind the propeller splines). The crankshaft is repairable by hard chroming this journal in accordance with Pratt & Whitney Plating Manual 238649.

Note: At 67 since major overhaul, it appears that no plating work was done to address the corrosion issues.

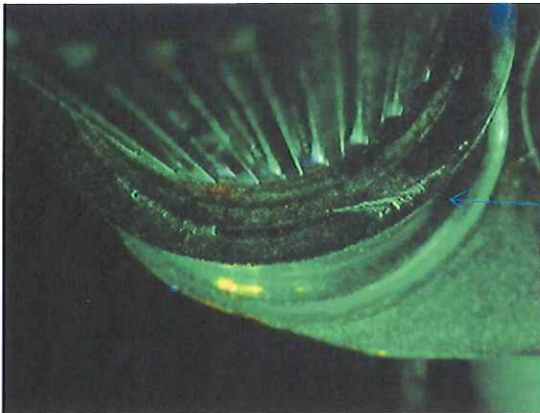
Crankshaft (S/N 20A6670) as photographed under a black-light (magnetic particle inspection). The crankshaft does show small crack indications that we feel can be addresses as per Pratt and Whitney repair instructions. We will need to remove the crack and measure to verify the serviceability of the part.

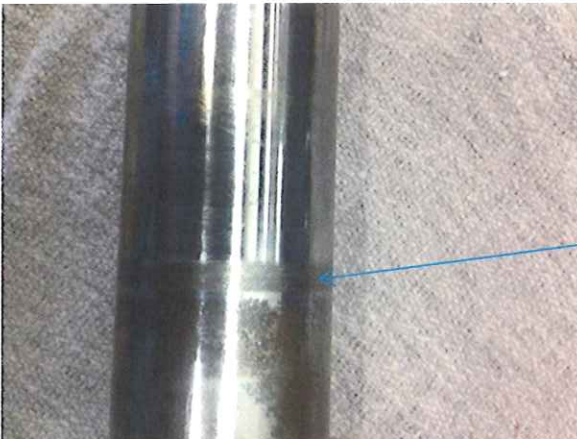
Piston Pin (P/N 234220) as removed from position (cylinder / piston) #3. Comparable to the remaining eight piston pins. The pins do not exhibit any corrosion however are pitted. The pin size in as removed condition is within service limits, however once the pitting is removed the pin sizing will need to be inspected and verified.

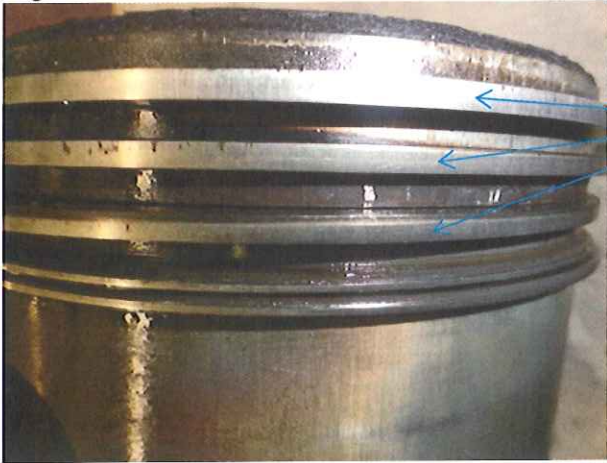
Piston as removed from cylinder #3.  
Comparable to the remaining eight pistons.  
The rings show excessive wear however  
side clearance / tolerance are within limits.

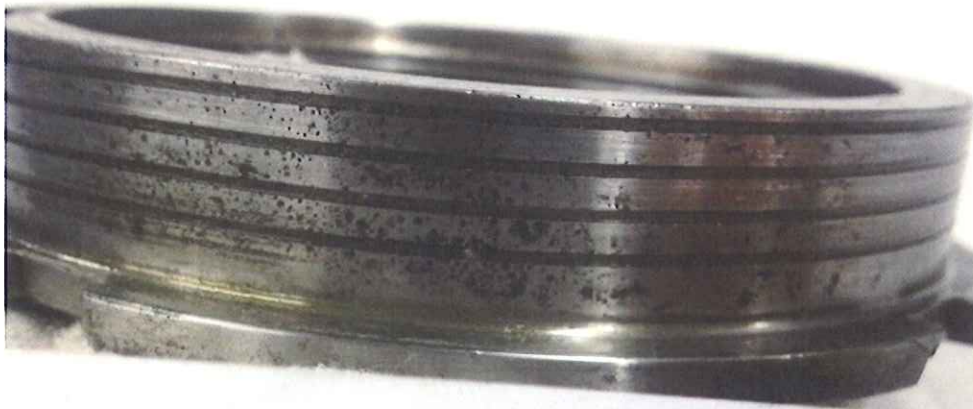
Photographed thrust nut  
(P/N 12719) as removed.  
No Rust or corrosion  
was found on the part,  
however there is  
significant pitting that  
condemns the part.

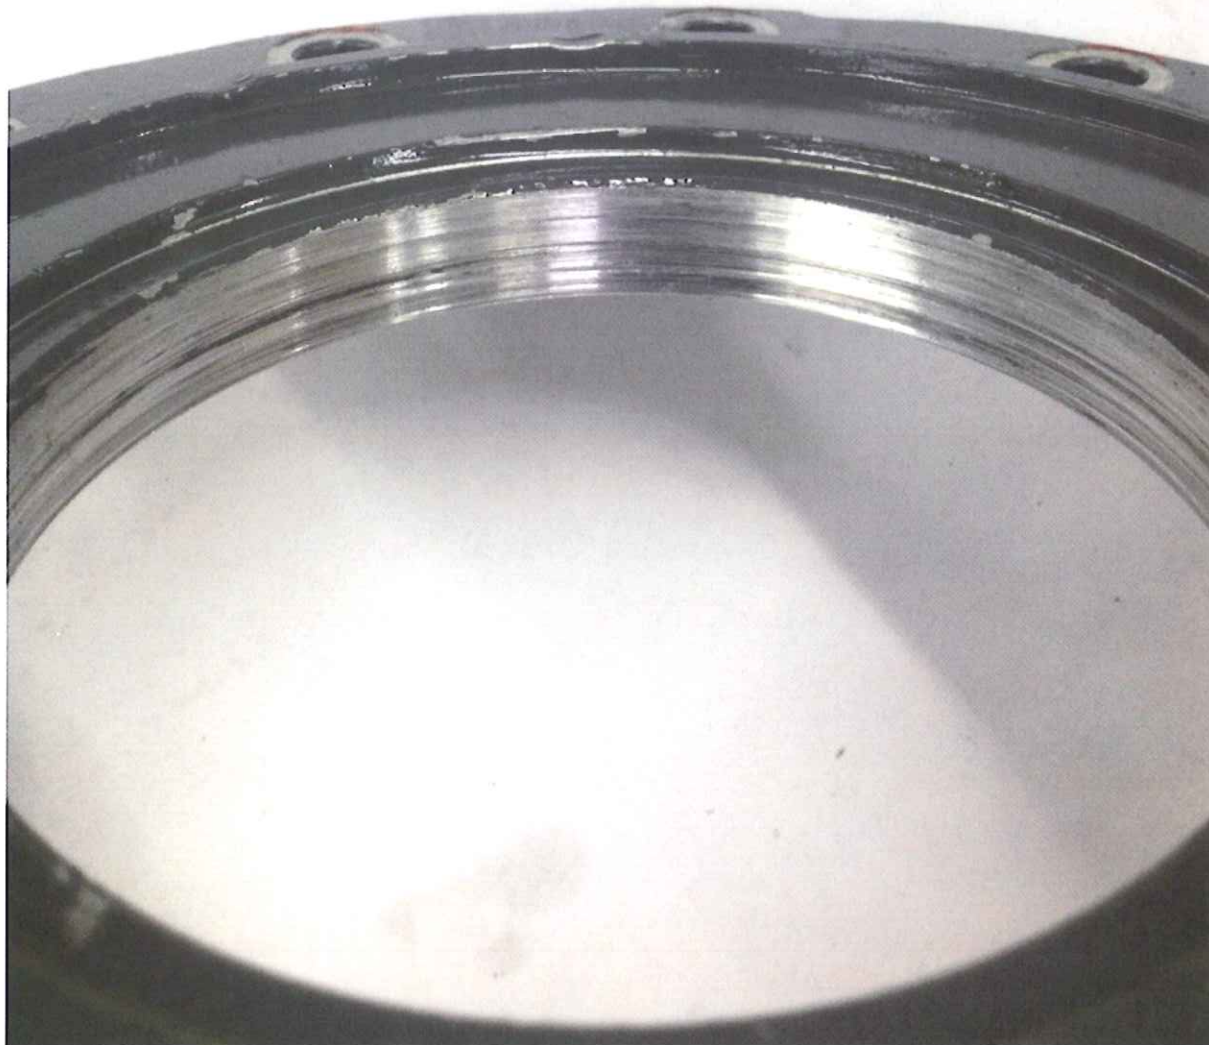
Photographed Thrust Plate (P/N 37970) as removed. Heavy scoring / gouging are present at the I.D. of the plate that will condemn the part. There is not found an operational cause for the condition of the part as the thrust nut shows no sign of corresponding damage.

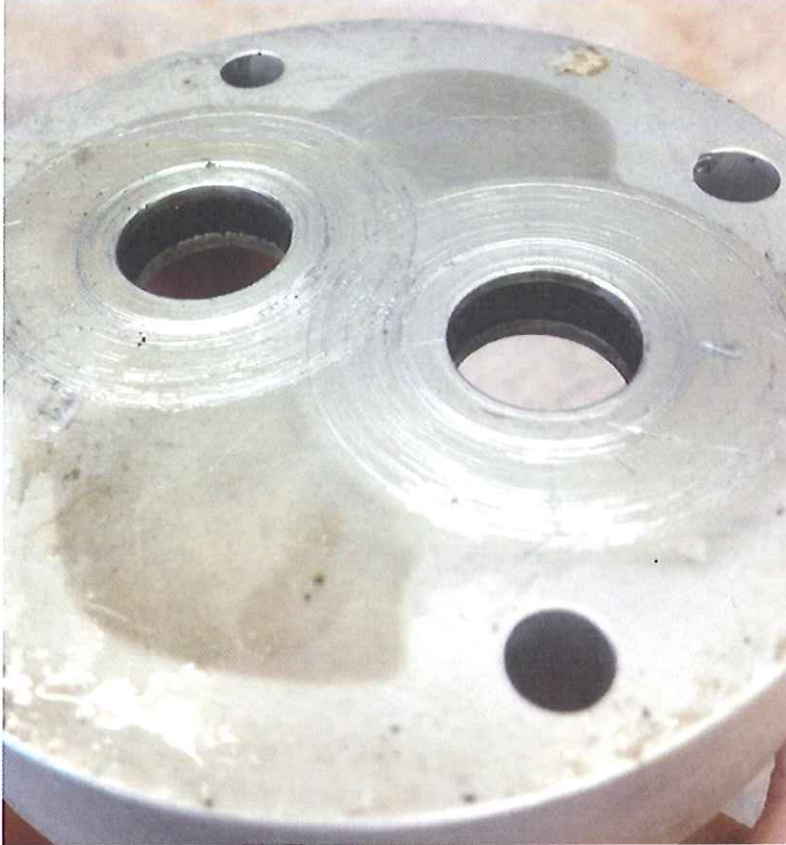
Photographed are seals (P/N 24230) located in the engine oil pump. The leather seals appear to be well worn and are semi-recessed in the housing.

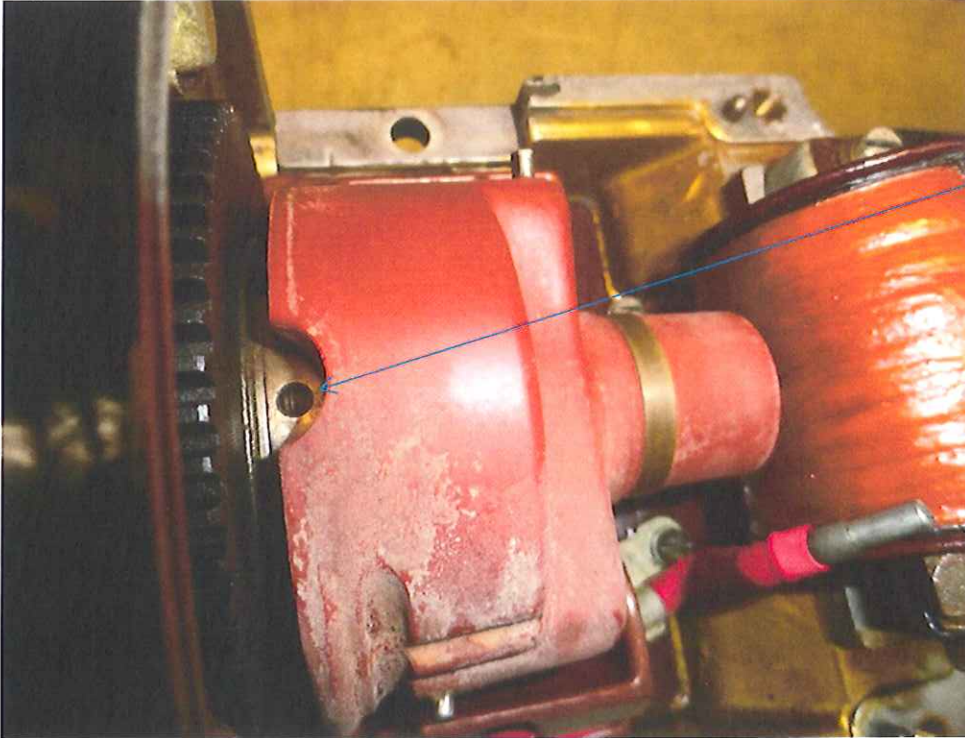
Note the following:  
The manual for the American Bosch (SB9RU3 / C3) magnetos require that the rotor fastening screws (P/N SC5294) be staked. Both fastening screws were un-staked as photographed.

Note that the hardware has not been plated or addressed, also the housings show chips and imperfections that should be addressed per the Overhaul / Service manual

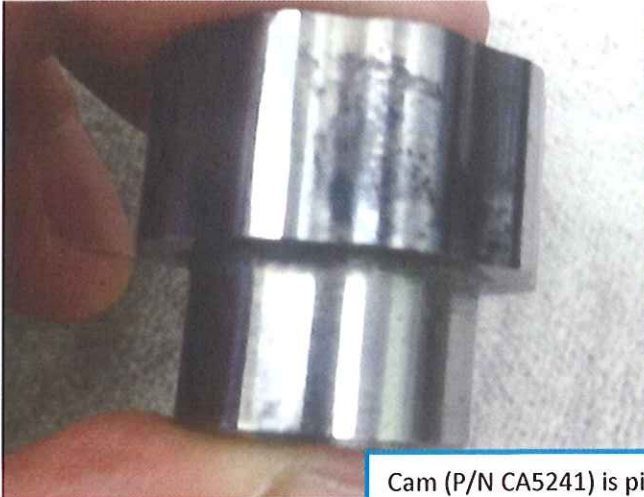
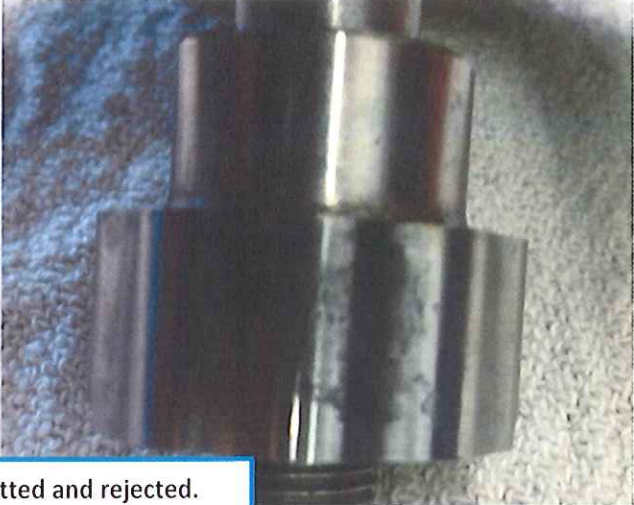
Cam (P/N CA5241) is pitted and rejected.

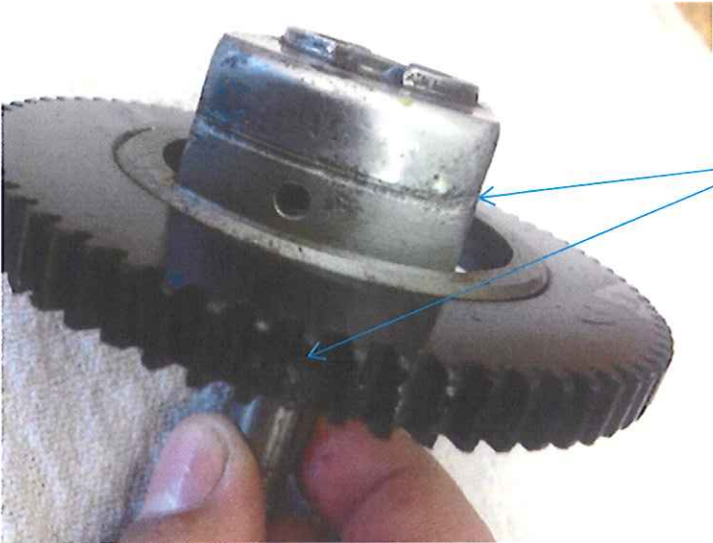
Gear (P/N GE52198) is pitted & has one gear tooth damaged. This part is rejected.

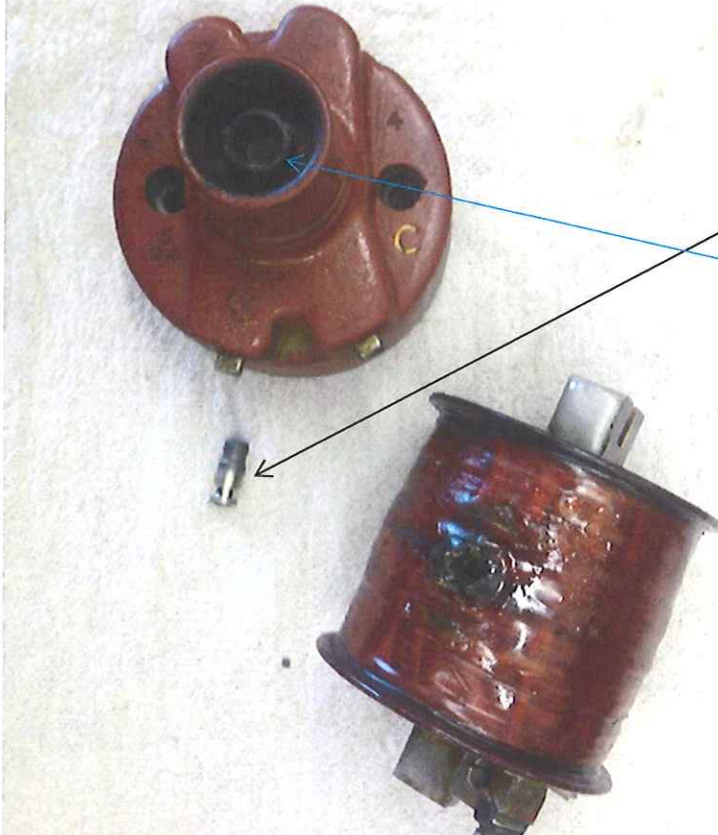
Rotor (P/N RT52137) & Coil (P/N CL5250) are rejected due to the coil terminal breaking loose from the coil. This terminal fits into the inner diameter of the rotor, because this terminal is loose it will (as the magneto is operating) damage the inner diameter of the rotor as photographed. It is possible for the magneto to keep operating with this failure, however most magnetos fail completely or exhibit high rpm drop when magneto checks are performed.

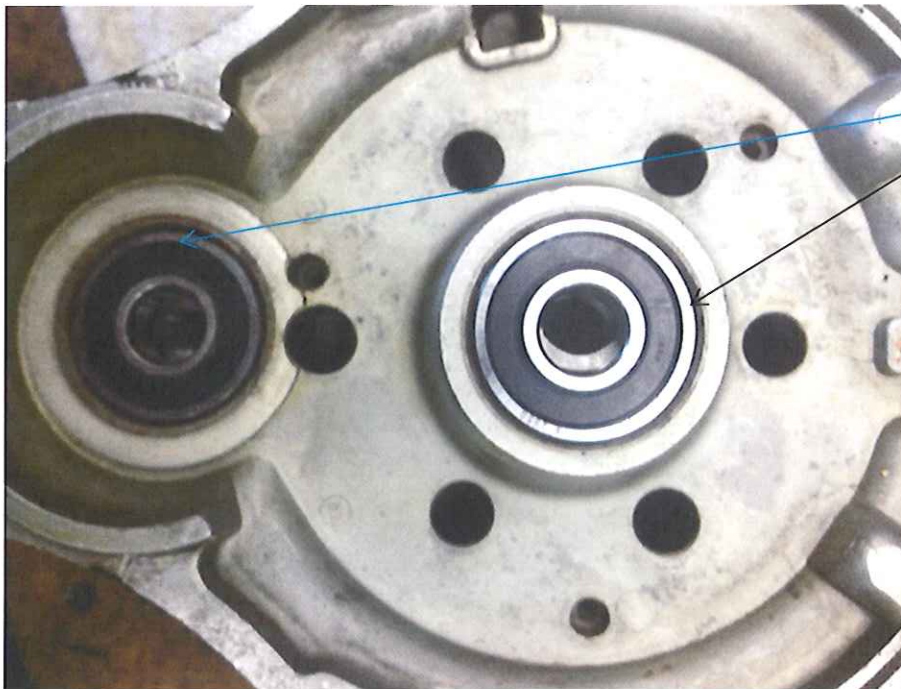
Incorrect bearings used. The manual calls for BB1019 & BB5210 slotted bearing. The bearings used appear to be SKF0201, which I cannot reference.

Also note that the sealer is nearly removed from the housing.

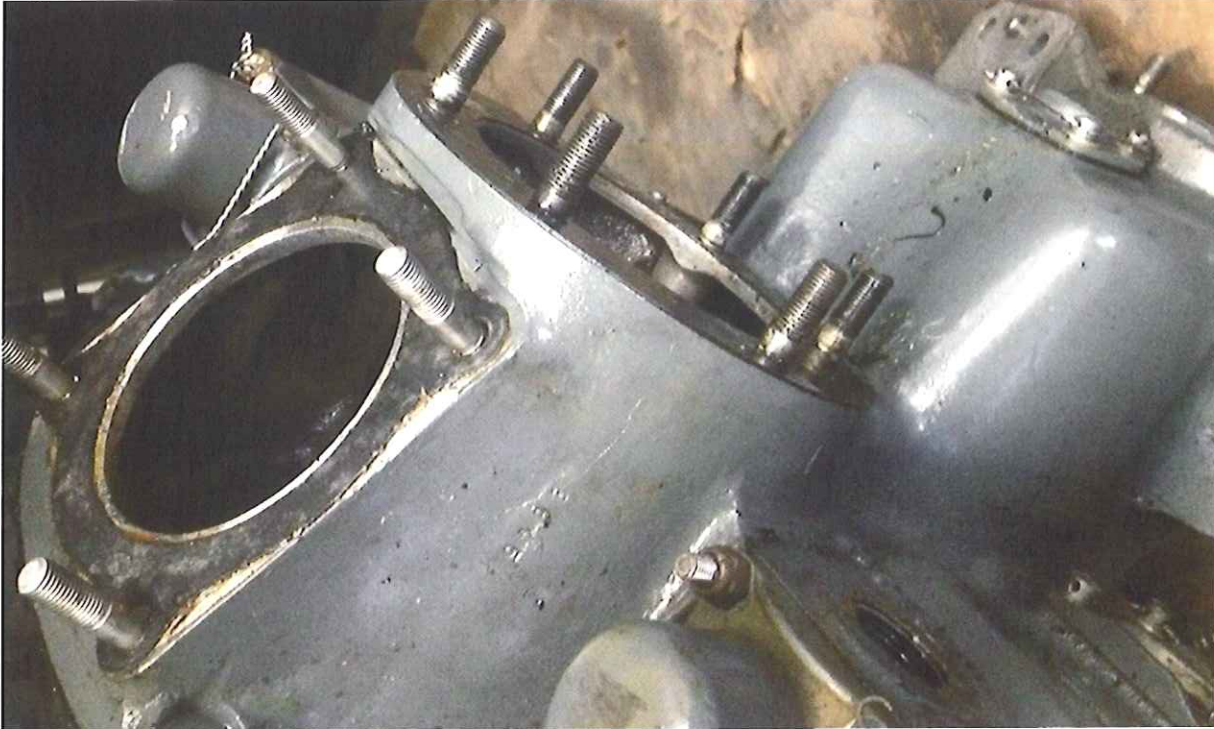
Reference "Rear Case Attachment". This is an enlarged illustration showing the relationship of the starter drive gear and the generator / alternator drive gear on the R-1340 engine rear case. The illustration contains item identification numbers, two of which I wish call your attention to; Item 215 and Item 219. Item 215 is the fit of the alternator drive gear housing to the rear case and Item #219 is the gear backlash between the starter jaw generator drive gear teeth and the generator drive gearshaft.

Item #215 is identified in the Limits Section of the R-1340 / Wasp Engine Overhaul Manual, Page 249 as; Generator Drive Housing – Rear Case, Minimum: .000" – Maximum: .004". Item #219 states: Starter Jaw – Generator Drive Gear Backlash, Minimum: .002" – Maximum: .030". Please study the illustration taking note of the Metal-to-metal placement of the generator drive gear housing (Item 215) and the relationship of the housing to the rear case itself. It becomes clear that accidental placement of a generator mount gasket between the generator drive gear housing and the rear case would alter the gear backlash (item #219) between the generator gear-shaft and the starter jaw resulting in excessive gear backlash.

Sustained operation of these gears with excessive gear backlash would result in a "hammering" effect, especially at engine idling speeds, and would result in premature failure of one or both gears. It is imperative that this gasket is placed in the proper location.

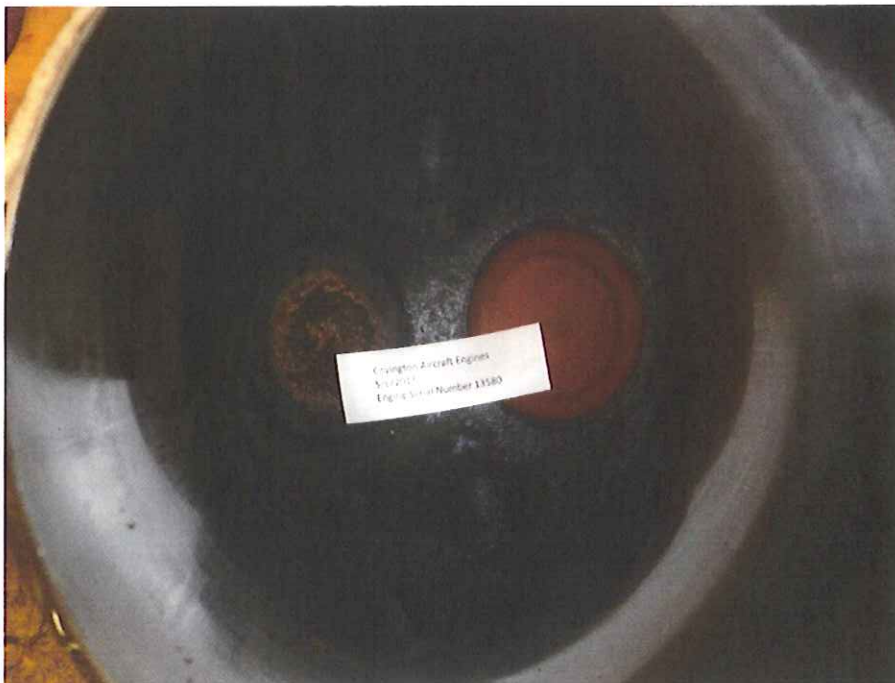
Note: The combustion chamber seems to have a high amount of combustion residue that would indicate that the engine did use (consume) more than average amounts of oil. This would be consistent with the marginal bore to piston sizing, apparent lack of honing, and excessively worn rings. To complete an inspection of the cylinders, valves, bearings & springs, full disassembly will be required.
